Recipients :	Stoneridge Network
Release date :	October 09 th , 2023
Update Purpose :	Added legal impact of GNSS fix on initial calibration
Object :	GNSS time adjustment, Smart 2 specificities

GNSS Time, Smart 2

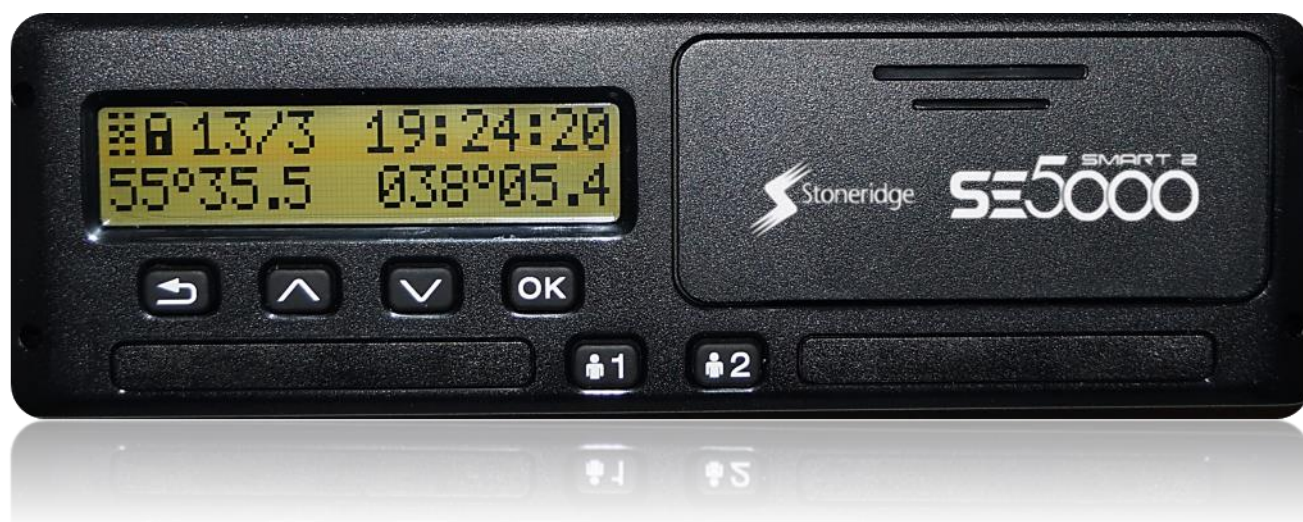
The GNSS signal can now be authenticated, as shown with the Padlock pictogram on the Latitude/Longitude display of the SE5000 INFO menu.

Moreover, any time drift larger than this, +/- 3 seconds, will trigger a time conflict event OB, saved in the tachograph memory and printed on the Fault & Event printout. A warning will also pop-up on the display.

To check whether the GNSS fix is available, navigate to the GNSS screen pictured above:

- From main menu press OK
- Press the Up arrow once to reach the INFO Menu, press OK
- Press the Down arrow 5 times to reach the Latitude/Longitude display
 - An active fix will show the time ticking every 1 second

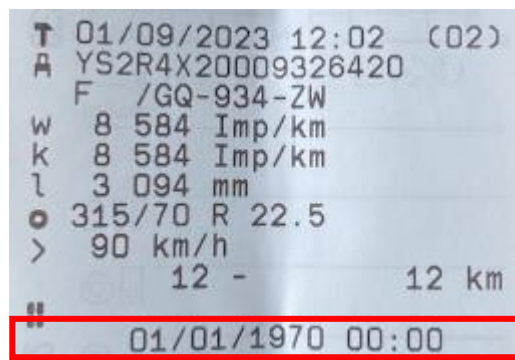
Part 1b – Run GNSS Test to verify Fix BEFORE calibrating tachograph

The consequence of above long time to first fix is that VU may be activated and calibrated before the GNSS position is acquired. This may have legal repercussions: if there is no GNSS fix since at least 2 minutes, any calibration block created will lack the indication of the country of calibration. This can be spotted easily since the timestamp of this missing country letter will show as 01/01/1970.
