Recipients :	All Markets
Release date :	June 5 th , 2024
Update Purpose :	First release
Object :	SE5000 Smart 2, Event !0D, Absence of GNSS signal for 3h of driving time

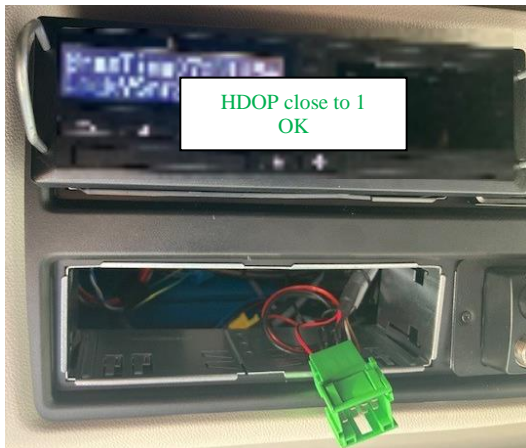
- Tolling devices,
- Telematic units,
- WLAN routers in Busses,
- Radios, etc...
- But also ECUs with no active GSM/BT/Wifi transmission, as illustrated in below case:

Good GNSS reception

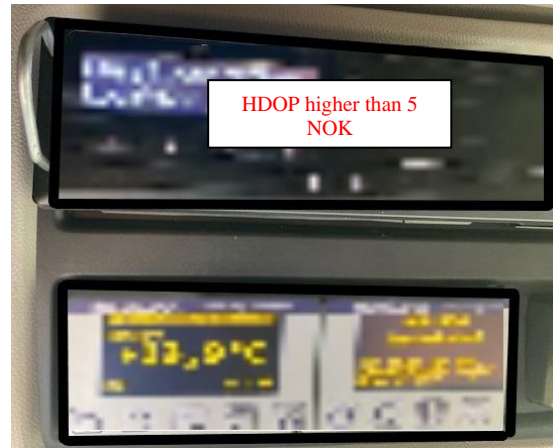
Poor GNSS reception

Also, if an Active transmitting ECU is identified as the rootcause of the GNSS interferences and cannot be relocated, please ask the manufacturer if an external GSM/Wifi antenna can be used. Install it as far away from the tachograph as possible.

Also, if cables are routed behind the tachograph, they must be pushed back and secured as far off the tachograph as possible, especially coaxial cables.
